# Deterioration of Tropical Stone Culture; Sri Lankan Experiences

Pathmakumara Jayasingha

**Citation:** Jayasingha, Pathmakumara, (2013), Deterioration of Tropical Stone Culture; Sri Lankan Experiences, The Journal of Archaeology and Heritage Studies, 1(2)

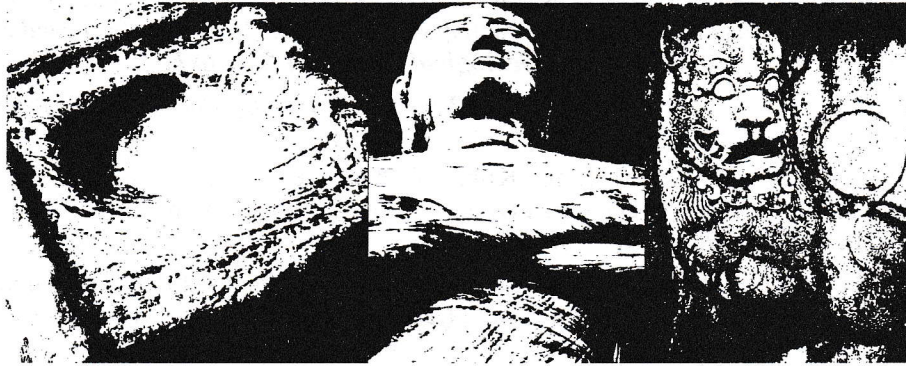
Figure 2: L). Grinding stone (Rambaviharaya) M). Standing budhdha statue (Galviharaya- Polonnaruwa) R). Lion figure (Anuradhapura)

remarkably evidenced. Almost all the studied stone monuments, sculptures, carvings and building components are made up of varieties of gneiss of Proterozoic high grade metamorphic rocks (Fig. 2a, 2b and 2c). Marble, impure marble and dolomitic marble were used for special purposes such as carving of Buddha statues (Ex; Samadhi statue in Anuradhapura) and decorative stones used in palaces and monasteries (Fig. 3a and 3b).

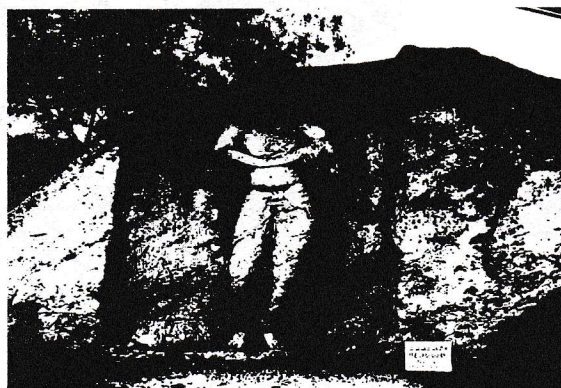
Figure 6: Statue of King or Sage carved on an exposed rock boulder (Polonnaruwa)

Discoloration is the most commonly observed deterioration feature in Polonnaruwa and Anuradhapura World Heritage Sites. Almost all the gneissic features developed by foliation and mineral lineation of statues of Galviharaya as well as that of a King or a sage, some stone components of Jethawanaya monastery, moonstones and guard stones are completely bleached (Fig. 6). It has been caused by the long term exposure of the statues and monuments to the sun light subsequent to the elimination of plaster or paint layers coated on them (Lee et al., 2006). It is well recognized that comparatively, discoloration in dry zone is high in strength than the wet zone.

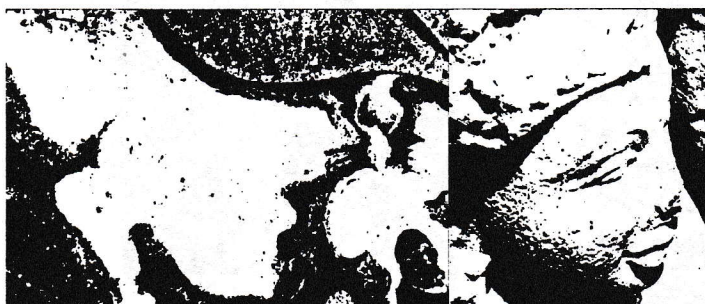
Figure 8. L) Cracks on crystals R) Loss of materials due to fragmentation (Anuradhapura)

Flaking and fragmentation due to various reasons have caused unrecoverable damages to the stone works of the country and in most cases loss of material is significantly observed. Small scale flaking has been caused by cracks in individual minerals, grain boundaries and joints as well as fractures of rocks. Cracks have been developed due to expansion of natural fractures in quartz, cleavages of feldspar, mica and hornblende in gneisses and calcite and dolomite in marble by hydrolyses and oxidation processes in wet climates. Thermally induced cracks in any mineral are commonly resulted in dry climates (Kranze, 1983; Smith, 2009). As a result, most of the edges of the statues and monuments have been fragmented and rounded. The famous guard stone and moonstones in Anuradhapura are worn out by flaking and fragmentation (Fig. 8a and 8b). It is also dominant in most of the marble carvings, statues and monuments in Rambaviharaya and Thissamaharamaya sites. The Samadhi statue in Anuradhapura and standing Buddha statues in Rambaviharaya have been severely fragmented. Loss of original shape devalues the stone heritage of the country.

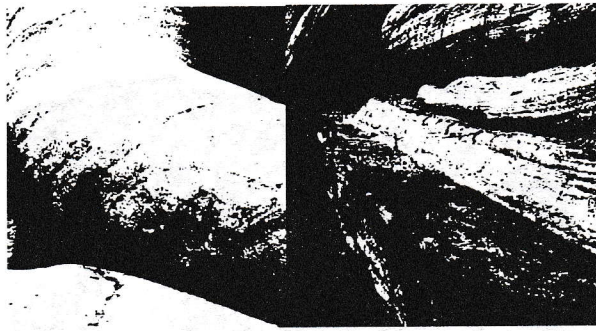
Figure 9. L) thermal cracks R) Splitting in Samadhi statute in Polonnaruwa

Two kind of splitting can be identified; structure related cracks and nonrelated cracks and they are most commonly found in the dry zone monuments and statues. The physical weathering in Samadhi Statue at Galviharaya is dominated by thermal cracks (Fig. 9a) which are not correlated with its own structural pattern of the bed rock. At the same time the structurally controlled cracks have been appeared in many places of the statue (Fig. 9b). Thermal expansion has caused

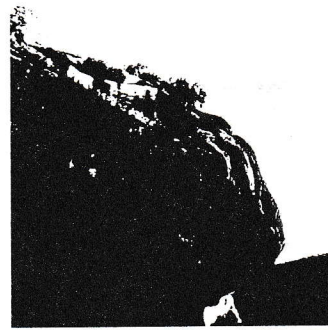
Figure 10. Blocking by splitting (Sigiriya)

severe splitting of the bed rocks in the places like Sigiriya (Jayasingha, 2005). The chemical weathering and structures of the rocks further augment the widening of cracks. Brutal splitting create blocking in small boulders and sudden detachment causes rock falling that can even damage the tangible heritage as well as tourists (Fig. 10).

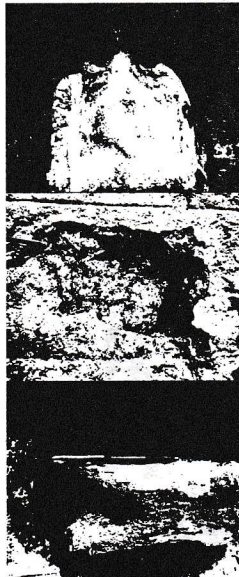
Figure 11. Impacts of salt crystallization (Gadaladeniya temple – Kandy)

Salt crystallizations are commonly found in the sites which are located in wet zone. One of the best examples is the Gadaladeniya Ancient Royal Temple in Kandy which was constructed using blocks of biotite hornblende migmatitic gneiss on the same exposed bed rock. The XRD analysis revealed that those salts are mainly gypsum formed by deterioration of the applied cement during the past conservation works (Fig.11). Salt crystallization enhances the flaking and fragmentation of the rock blocks further.

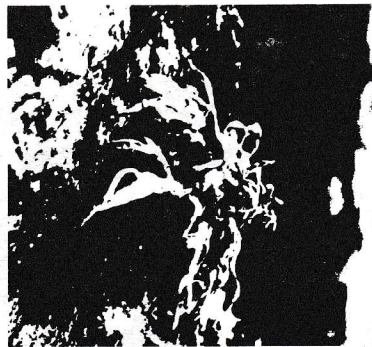
Figure 14. *Usnea* sps on Sigiriya rock

Most commonly observed lichen type is the crustose which does the pioneering work in monument deterioration. The common species of crustose are *Xanthoparmelia* spp, *Xanthoria* spp and *Lecanora* spp. Some squamulose type lichens were also recorded. In addition, *Usnea* spp is the only species of fruticose type noted in the study sites (Fig. 14).
